# Universal Design in the Metrobuss System of Trondheim, Norway – Challenges and Solutions

Jacob DEICHMANN<sup>1</sup>  
Rambøll Danmark AS

**Abstract.** The presentation describes challenges and possible solutions for achieving truly accessible high-class urban public transportation based on a case from Trondheim, where a new high-class bus system was implemented. The implemented solution did not reflect the wheelchair user's needs— despite clearly stated ambitions for accessibility.

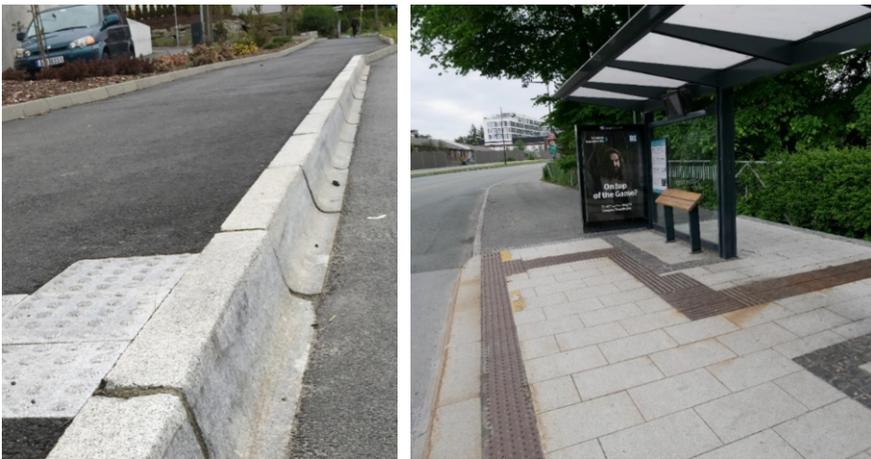
The stations were built according to Norwegian State guidelines for accessible road design [2]. A central feature of bus stop design here is a kerb that is 18 cm high. The kerb has a slightly receding profile, with a curve at the bottom, designed to encourage the bus driver to drive as close to the kerb as possible (Figure 1, left)

Figure 1. Left: Detail of the 18 cm kerb (photo: Manufacturer). Right: Tactile surfaces at a Metrobuss station (photo: the author)

The platforms are also fitted with a system of tactile guiding surfaces, primarily to aid blind and visually impaired passengers to find the front door of the bus. (Figure 1, right).

The BRT standard [1] allows for a maximum gap of 5 cm between platform and bus floor (which is even a large gap for some wheelchair and walker users). A kerb height of 18 cm and a bus floor level of 25-27 cm results in a vertical gap of 7-9 cms. To this can be added the horizontal gap between bus and kerb edge. This gap depends very much on the skill of the driver and the detail of the kerb design.

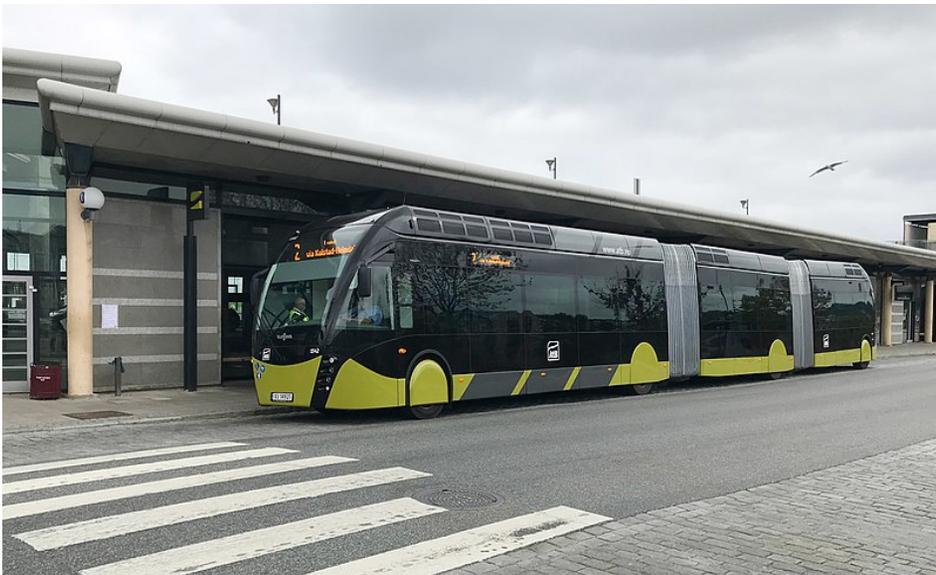
The bus can reach a floor level at the doors of 25-27 cm by “kneeling” (meaning that one side of the bus is lowered at bus stops using a hydraulic mechanism).

Figure 2. A VanHool Equicity Bus (photo Wikipedia)

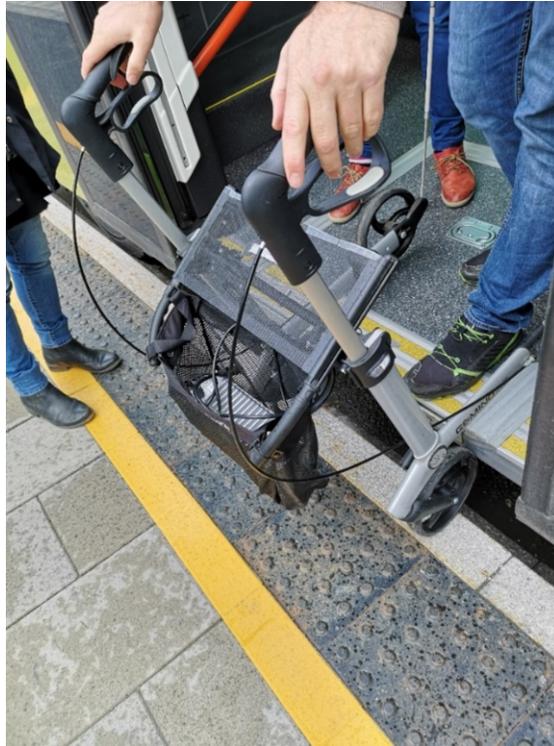
Figure 3. Vertical and horizontal gap shown by a rollator (walker) user (photo: Rambøll)

Due to the design of the wheel casings the bus cannot get as close to the kerb as expected or needed, meaning that the horizontal gap remains a problem; even if the bus floor can come closer to the kerb height.

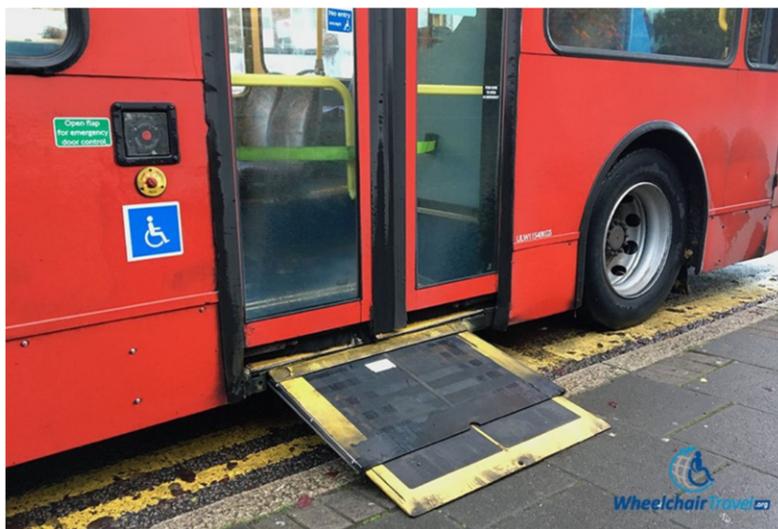
Figure 5. Motorized ramp, telescope system (solution no. 3)

- Motorized ramp, telescope system to be fitted on one bus.
- Bus pad to be mounted on one station and tested
- Guiding system to be tested

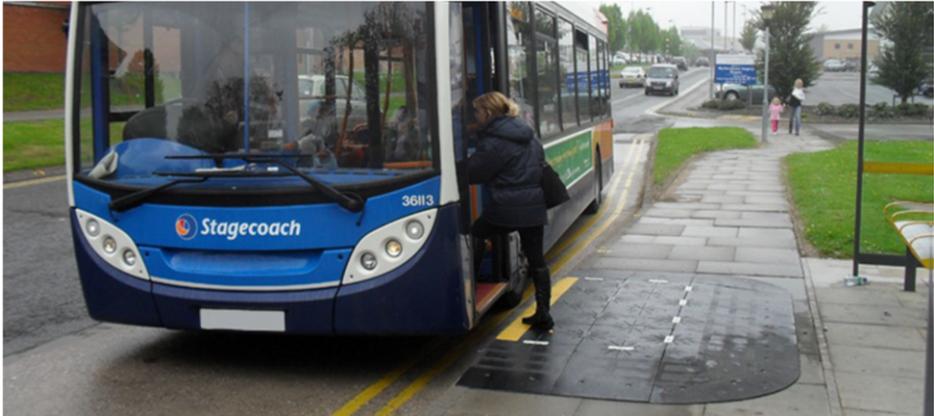
Figure 6. Bus Pad (solution no. 8)
